2006 ECI Conference on Geohazards

Instrumentation of Flexible Buried Culvert
Subjected to Rockfall Loading

R. Ebeltoft*

J. O. Larsen[†]

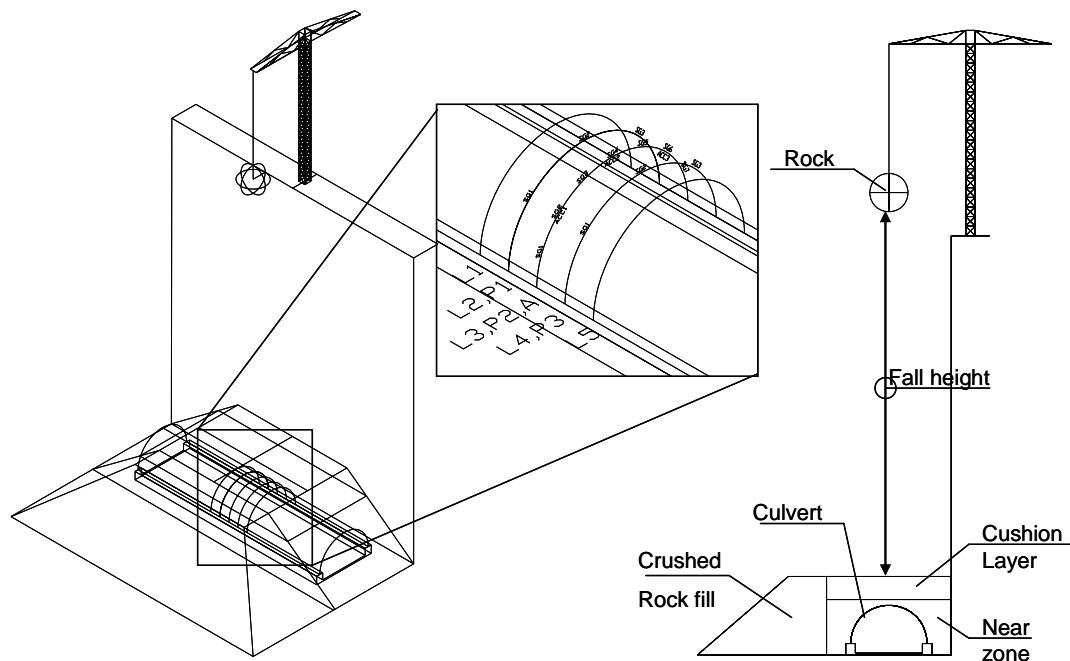
Figure 1: Illustration of experimental setup. Inset shows the different profiles where measurements were carried out.

The 15.0 m long structural plate metal arch culvert was installed on a reinforced concrete plate foundation, Figure 1. 80-200 mm size compacted gravel was used as backfill at the ends.

After completion of installation impact load tests were conducted. In the present study, natural rock boulders have been used, and the impact of these rocks are centered above the crown of the culvert. After each impact test the cushion layer was removed and replaced to same level. Figure 1 represents the experimental setup.

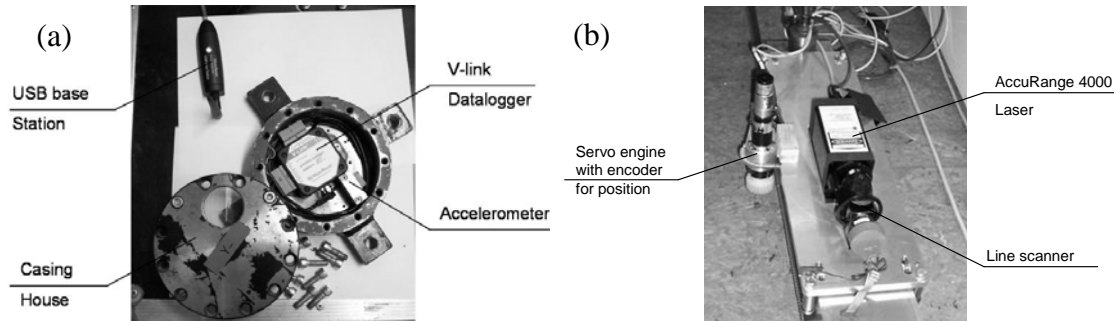
Figure 2: (a) Accelerometer device used to acquire deceleration history of rock impact, (b) laser device used to detect deformations of the culvert.

Figure 2a) shows the accelerometer device that was fitted with a wireless MicroStrain V-link data acquisition system. The accelerometers used were IC Sensor model 3031-100.

Each rock block was successively equipped with this device to measure the deceleration history in three directions. Three accelerometers were installed inside the culvert to measure transmitted accelerations. The accelerometers used were PCB Piezotronics model 353B03. These were installed at profile A, as shown in Figure 1. Strain gages were installed as Wheatstone half bridges. A total of 40 strain gages were installed in the corrugated culvert. These consisted of both the glue type HBM LY61-6/350 and the weldable type LS31-6/350. Strain gages were installed at profiles P1-P3. Installation was conducted as described in Webb et al. (1999). A Phantom v5 high-speed camera was used to observe the impact of the rock blocks onto the soil cushion layer.

Figure 2b show the laser device, AccuRange 4000 equipped with a rotating line scanner, which was mounted on an automated wagon to obtain deformations while construction and during the impact tests (Webb et al., 1998). During construction, after placement of each layer, the laser wagon was used to monitor the profiles L1-5 as described in Figure 1. The electrical servo engine had an encoder that ensured the position of the laser device in the longitudinal direction. After impact tests the laser device was also used to monitor the same profiles to detect permanent deformations of the culvert.

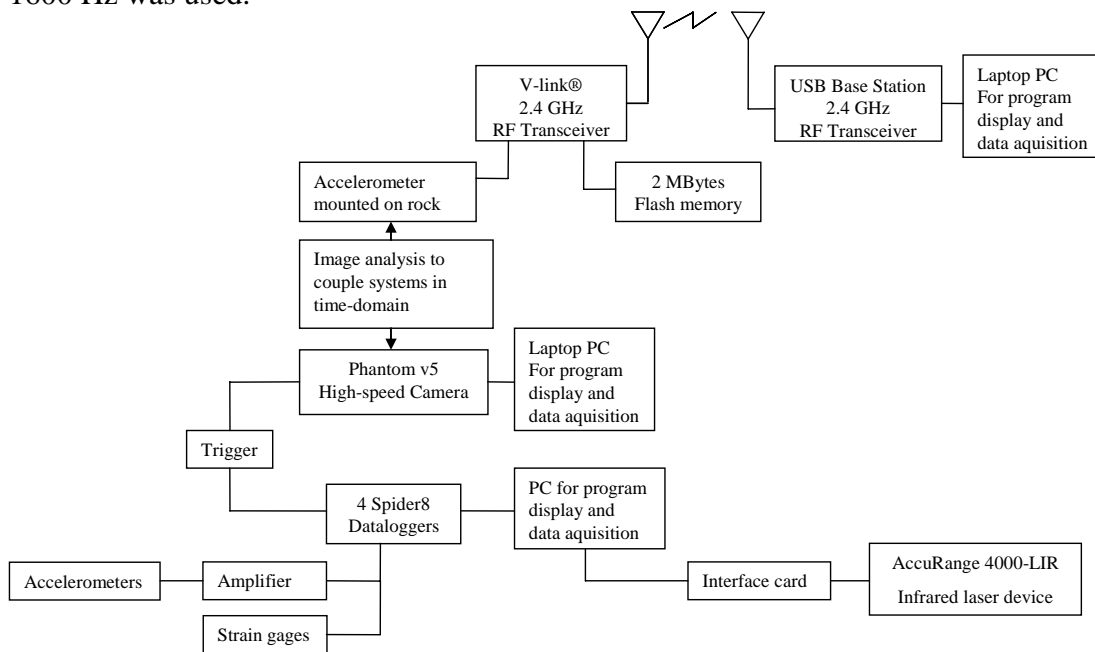
Figure 4: Schematic layout of data acquisition system.

A trigger system ensures that the high-speed camera, accelerometers and strain gages were started simultaneously. Due to the independence between the V-link acquisition system and the Spider 8 acquisition system, image analysis was performed on the high speed images to correlate the deceleration history of rock and the rest of the system.

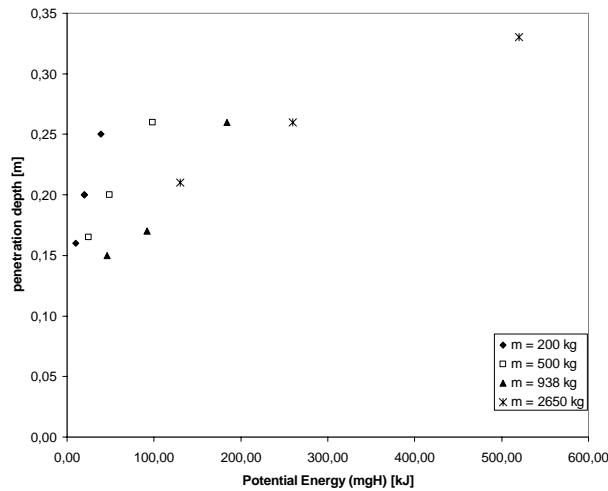
Figure 5: Penetration depth vs Energy for rockfall tests with rock masses of 200, 500, 938 and 2650 kg. Fall heights varying from 5, 10 and 20m.

Figure 5 present observed penetration depths from the rock fall testing. Penetration depth was measured by means of a stadia rod. As shown in figure the penetration depths (15-32 cm) is increasing with the increasing mass and fall heights. This also indicates high energy dissipation with increasing impact loading.

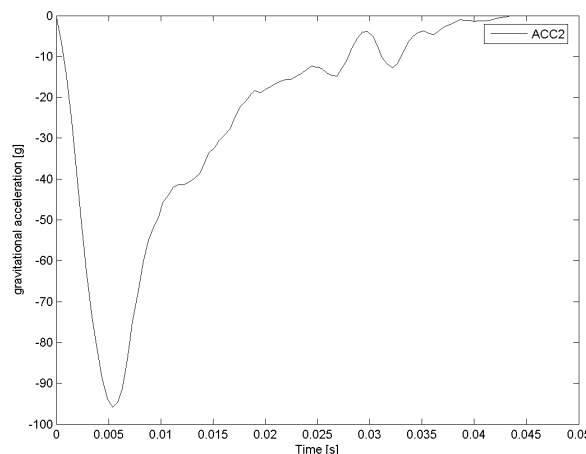
Figure 6: Typical deceleration history of low-energy rockfall impact.

Figure 6 present a typical vertical deceleration history from the rockfall impact tests. Duration of this impact is in the order of approximately 40 ms. Measured peak acceleration is approximately 90 g.

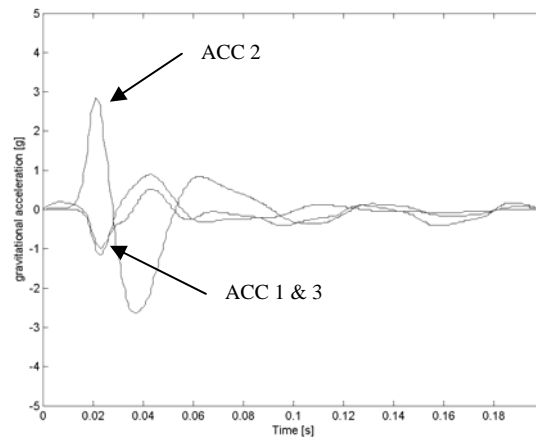
Figure 7: Measured accelerations in the culvert at profile S2 during impact.

Figure 7 show a typical measurement of transmitted accelerations occurring in the culvert during impact. The figure shows that the impact load generates downward accelerations at the crown (ACC2) of the culvert, and outward accelerations for the other accelerometers (ACC1 and ACC3). The impact generate an oscillation that is highly damped and lasts for only about 100 ms. The energy of the impact is in part absorbed by the soil cushion and in part transmitted through the soil and the structure to the surroundings.

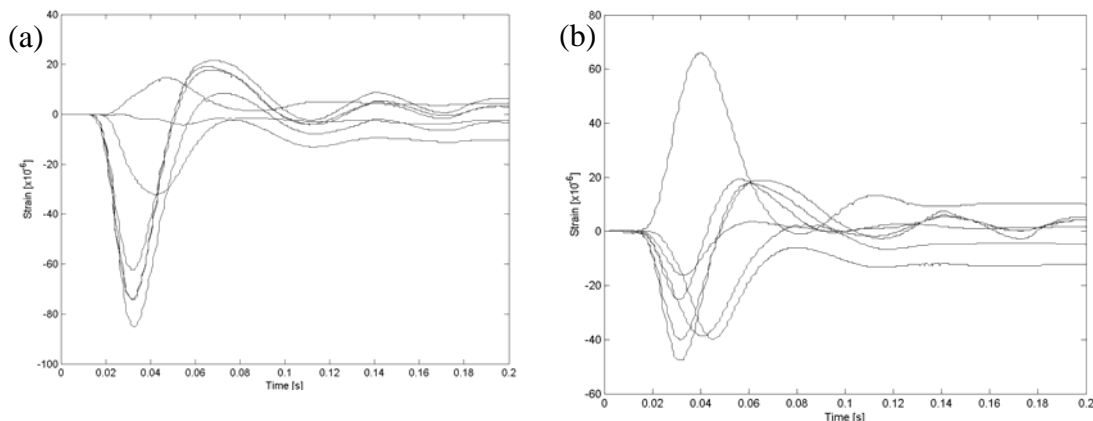
Figure 8: (a) Measured axial strains for the culvert at profile P2 during impact and (b) bending strains for the culvert at profile P2 during impact.

Figure 8 shows a typical measurement of dynamic strains during a low-energy impact. Initial strains during construction phase have been reset to zero. Measured axial strains, presented in Figure 8(a), show that most of the structure is compressed during impact. Figure 8(b) show bending strains during impact where positive strains are inward bending, while negative strains are outward. This is characterized as a small depression at the crown, while the sides are deflecting outward.
